Manhole Inspection Summary

Manhole # S23Y__002MH

Insp Date: **6/2/09 10:16 AM**

Location Address: **2220 SEVERN ST**

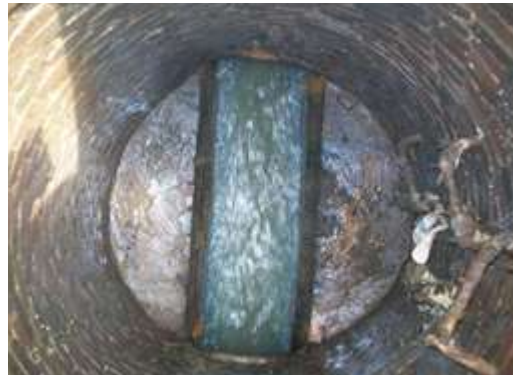
Top View

Comments **BROKE AND REPLACED COVER TO GAIN ACCESS AND COMPLETE INSPECTION;
REPLACED WITH WATER TIGHT LID**

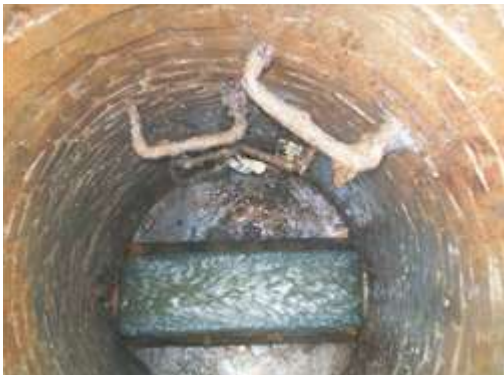
Defect 2

Steps Count: **6** Missing: **0** ☒ **Corroded**

CORRODED STEPS

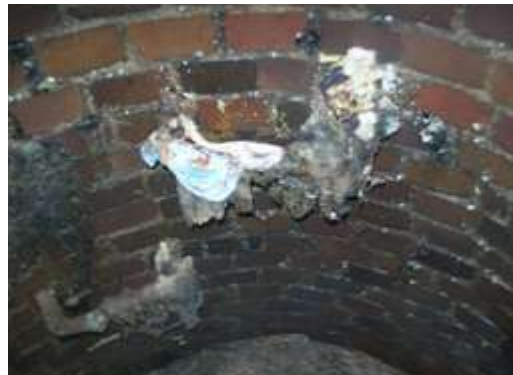
Defect 1

Surcharge ☒ **Evidence Of Surcharge** Depth: **8** (ft.) ☐ Active Surcharge Present

EVIDENCE OF SURCHARGE

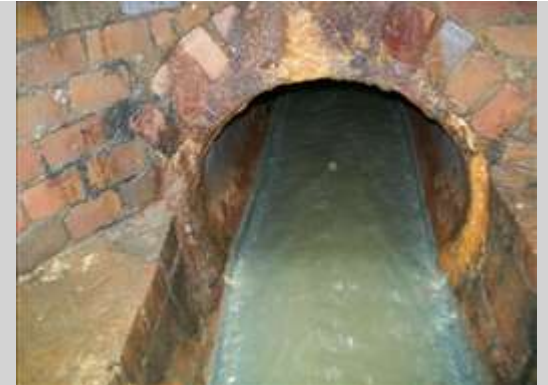
12 O'Clock Outflow

21 in. Circular Gravity Sewer
Pipe Out @ 12 O'Clock

Pipe Height: **21.6** (in.) Rod and Bar (Angled)
Pipe Material: **Clay** ☐ Pipe Lined
Invert Depth: **11.70** (ft.) Flow Characteristics: **Slow**
Deposits: ☒ None ☐ Mud ☐ Sludge ☐ Debris ☐ Grease
Silt Depth: **0** (in.) Deposits Extent:
Infiltration: **Weeper** Pipe Seal Cond: **Unknown**

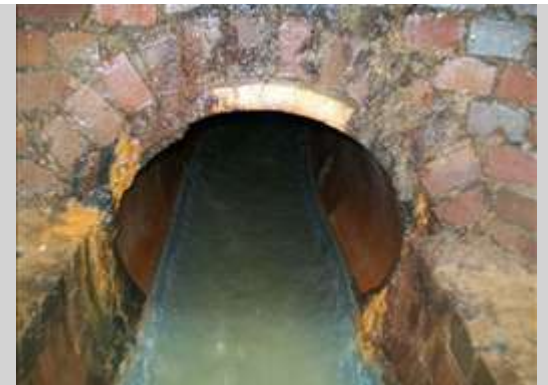
6 O'Clock Inflow

21 in. Circular Gravity Sewer
Pipe In @ 6 O'Clock

Pipe Height: **21.6** (in.) Rod and Bar (Angled)
Pipe Material: **Clay** ☐ Pipe Lined
Invert Depth: **11.60** (ft.) Flow Characteristics: **Slow**
Deposits: ☒ None ☐ Mud ☐ Sludge ☐ Debris ☐ Grease
Silt Depth: **0** (in.) Deposits Extent:
Infiltration: **Weeper** Pipe Seal Cond: **Sound**
